**Flood Control Project Maintenance
Levee Inspections**

Fall 2013 Levee Maintenance Deficiency Summary Report

Sacramento River Basin

Reclamation District No. 0785 Driver

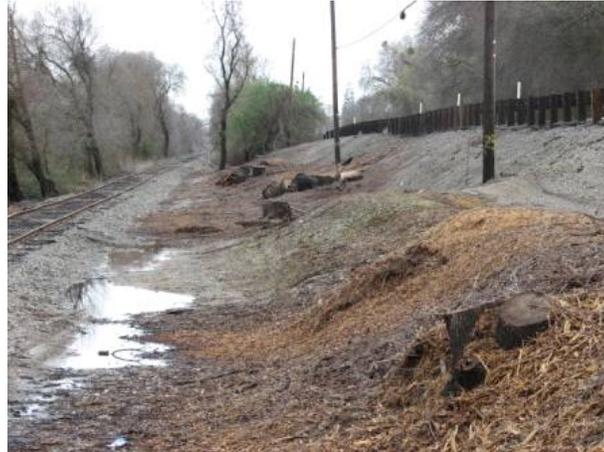
Levee Mile Report Line	5
Start Levee Mile	0.13
End Levee Mile	1.36
Location	Land Side
Category	Earthen Levee
Item	Trim / Thin Trees
<p>The trees were cut by PG&E'S tree contractor. The district will take care of the stumps in the future.</p>	
<p>johngw_f_20131021_557.jpg</p>

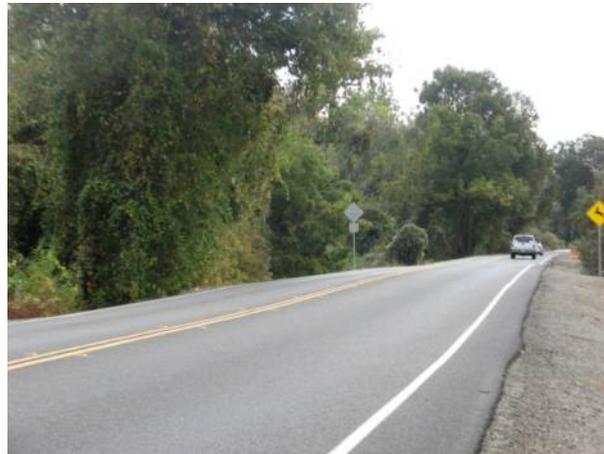
Levee Mile Report Line	6
Start Levee Mile	0.21
End Levee Mile	0.57
Location	Water Side
Category	Earthen Levee
Item	Vegetation
<p>Brush and other vegetation partially blocks visibility or access to the levee slope. Fall 2013</p>	
<p>johngw_f_20131104_282.JPG</p>

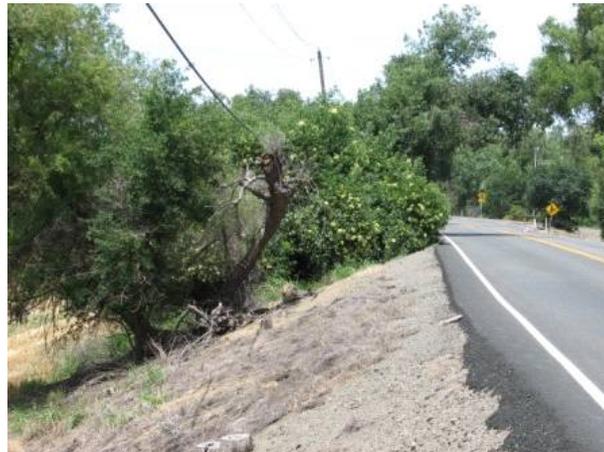
Levee Mile Report Line	8
Start Levee Mile	0.29
End Levee Mile	0.29
Location	Land Side
Category	Earthen Levee
Item	Vegetation
<p>Elderberry</p>	
<p>johngw_f_20131021_555.jpg</p>

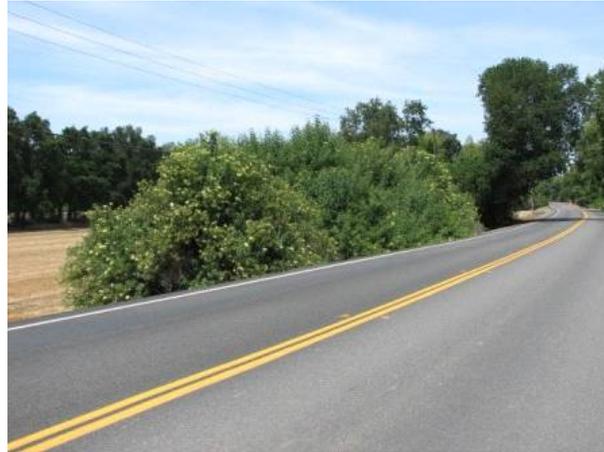
Levee Mile Report Line	9
Start Levee Mile	0.41
End Levee Mile	0.45
Location	Land Side
Category	Earthen Levee
Item	Vegetation
Elderberry	
johngw_f_20131021_556.jpg

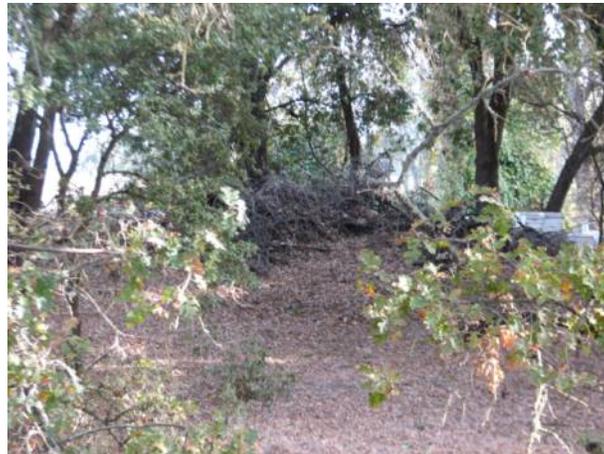
Levee Mile Report Line	10
Start Levee Mile	0.68
End Levee Mile	0.68
Location	Land Side
Category	Earthen Levee
Item	Encroachments
Pruning pile on the landside shoulder. Fall 2013	
johngw_f_20131104_279.JPG

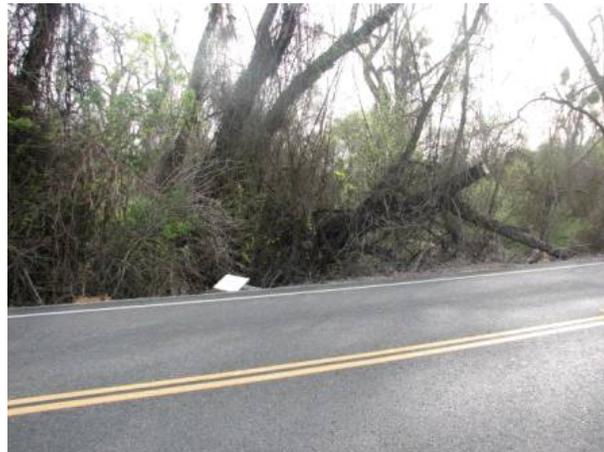
Levee Mile Report Line	12
Start Levee Mile	0.93
End Levee Mile	0.93
Location	Water Side
Category	Earthen Levee
Item	Trim / Thin Trees
The fallen tree and brush on the waterside of the roadway needs to be removed. Photo taken spring 2012.	
johngw_f_20131021_567.jpg

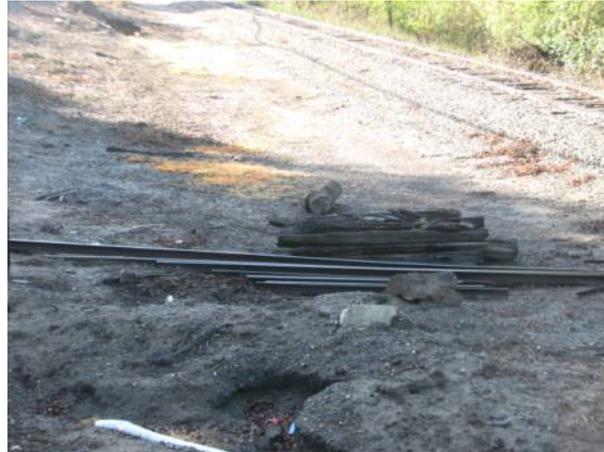
Levee Mile Report Line	13
Start Levee Mile	1.08
End Levee Mile	1.08
Location	Land Side
Category	Earthen Levee
Item	Encroachments
<p>Railroad ties and rails lay along the toe of the levee. Spring 2013</p>	
<p>johngw_f_20131021_562.JPG</p>

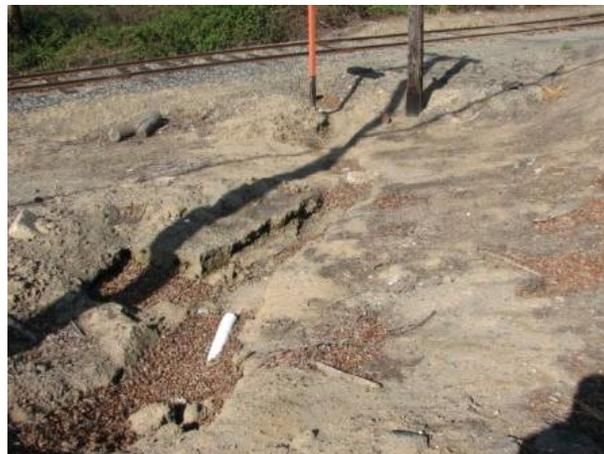
Levee Mile Report Line	14
Start Levee Mile	1.08
End Levee Mile	1.08
Location	Land Side
Category	Earthen Levee
Item	Erosion / Bank Caving
<p>The drain pipe across from the firehouse has caused erosion, photo taken spring 2012.</p>	
<p>johngw_f_20131021_568.jpg</p>

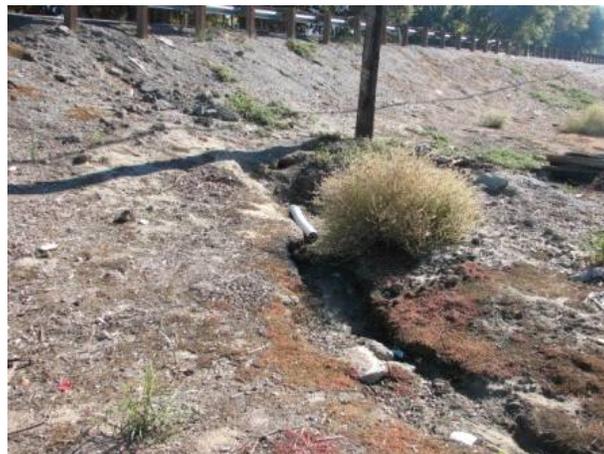
Levee Mile Report Line	14
Start Levee Mile	1.08
End Levee Mile	1.08
Location	Land Side
Category	Earthen Levee
Item	Erosion / Bank Caving
<p>Erosion on the levee slope and toe. Fall 2012</p>	
<p>johngw_f_20131021_569.jpg</p>

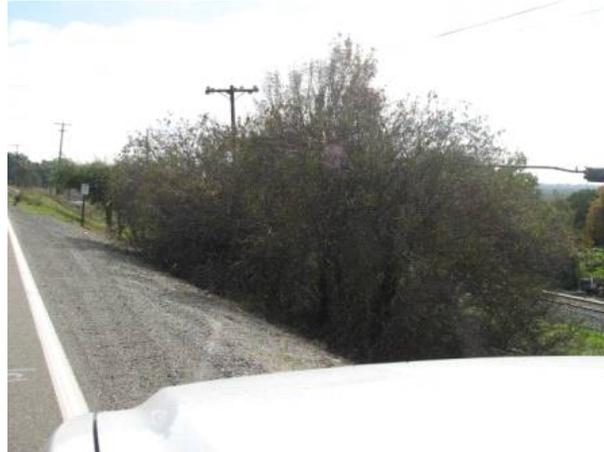
Levee Mile Report Line	15
Start Levee Mile	1.32
End Levee Mile	1.32
Location	Land Side
Category	Earthen Levee
Item	Vegetation
This is a very large Elderberry bush.	
johngw_f_20131021_558.jpg

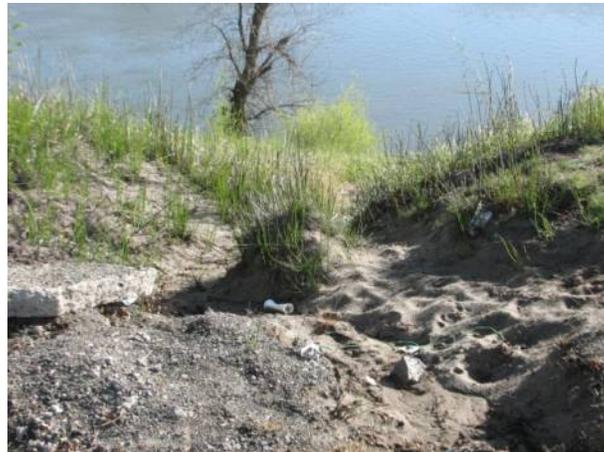
Levee Mile Report Line	16
Start Levee Mile	1.32
End Levee Mile	1.32
Location	Water Side
Category	Earthen Levee
Item	Erosion / Bank Caving
The waterside levee slope has erosion from surface run off. Spring 2013	
johngw_f_20131021_563.JPG

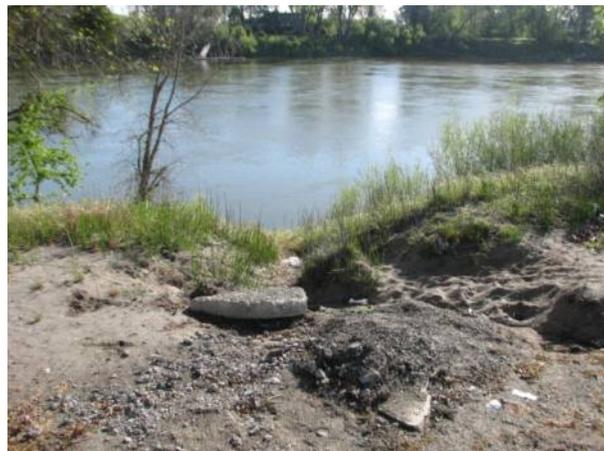
Levee Mile Report Line	16
Start Levee Mile	1.32
End Levee Mile	1.32
Location	Water Side
Category	Earthen Levee
Item	Erosion / Bank Caving
The erosion has become a trail for fishermen and contributes to it. Spring 2013	
johngw_f_20131021_564.JPG

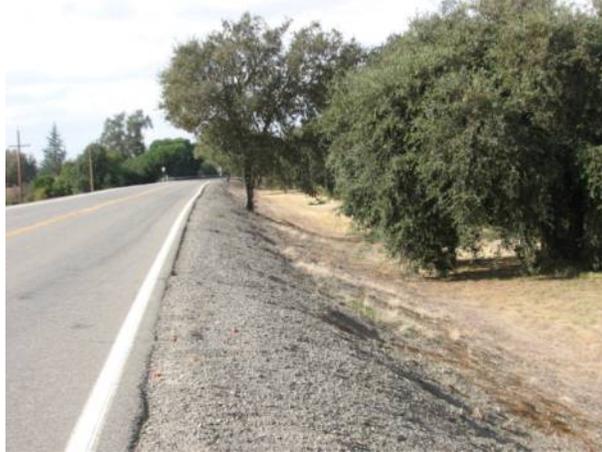
Levee Mile Report Line	17
Start Levee Mile	1.45
End Levee Mile	2.30
Location	Water Side
Category	Earthen Levee
Item	Vegetation
The vegetation complies with standards no brush or undesirable weeds. Fall 2013	
johngw_f_20131104_281.JPG

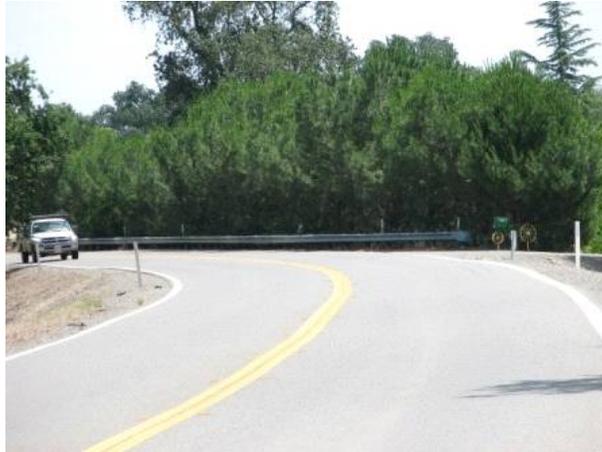
Levee Mile Report Line	18
Start Levee Mile	2.04
End Levee Mile	2.14
Location	Land Side
Category	Earthen Levee
Item	Vegetation
Pines and oleanders along shoulder.	
johngw_f_20131021_559.jpg

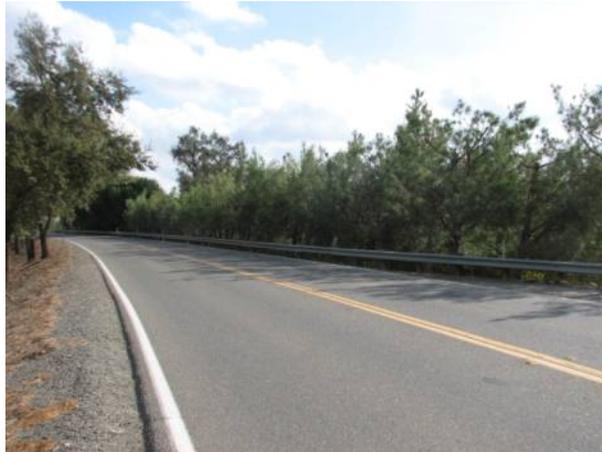
Levee Mile Report Line	18
Start Levee Mile	2.04
End Levee Mile	2.14
Location	Land Side
Category	Earthen Levee
Item	Vegetation
The pine trees along the shoulder have been topped and thin out. Oleanders still on the shoulder. Fall 2013	
johngw_f_20131104_280.JPG

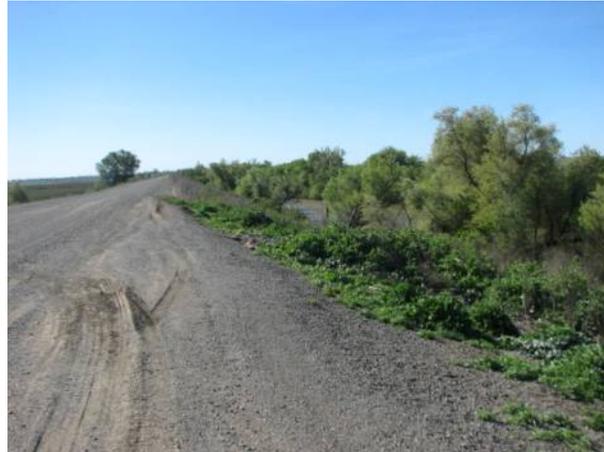
Levee Mile Report Line	1
Start Levee Mile	0.01
End Levee Mile	0.62
Location	Water Side
Category	Earthen Levee
Item	Vegetation
The vegetation is taller then 12". Spring 2013	
johngw_f_20131021_571.JPG

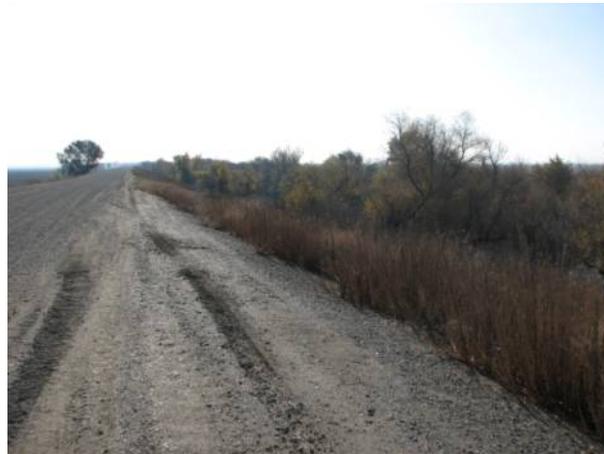
Levee Mile Report Line	1
Start Levee Mile	0.01
End Levee Mile	0.62
Location	Water Side
Category	Earthen Levee
Item	Vegetation
Tall weeds block visibility of the levee slope. Fall 2013	
johngw_f_20131126_352.JPG

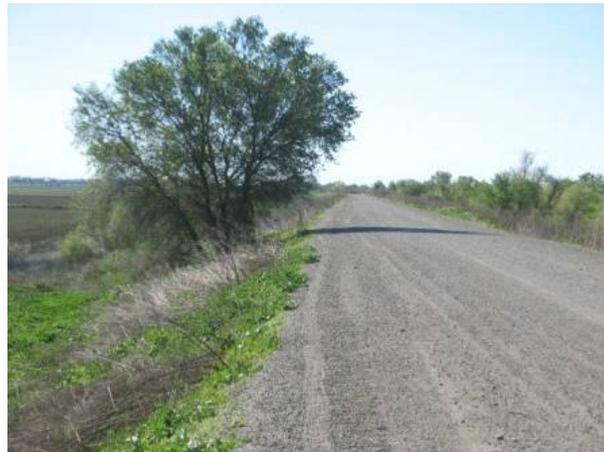
Levee Mile Report Line	2
Start Levee Mile	0.04
End Levee Mile	0.41
Location	Land Side
Category	Earthen Levee
Item	Vegetation
The vegetation is thaller then 12". Spring 2013	
johngw_f_20131021_570.JPG

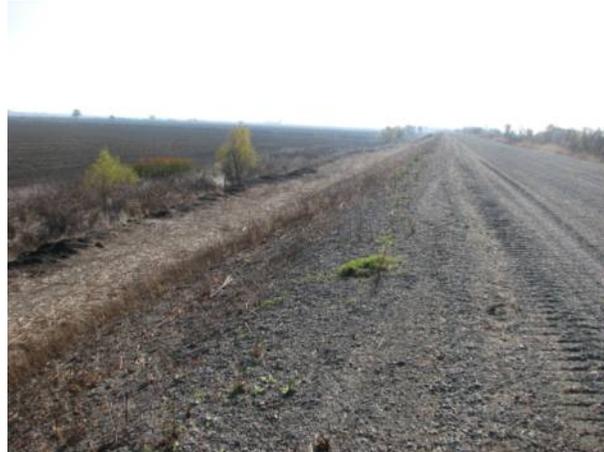
Levee Mile Report Line	2
Start Levee Mile	0.04
End Levee Mile	0.41
Location	Land Side
Category	Earthen Levee
Item	Vegetation
The vegetation does not block visibility of the levee slope. Fall 2013	
johngw_f_20131126_353.JPG

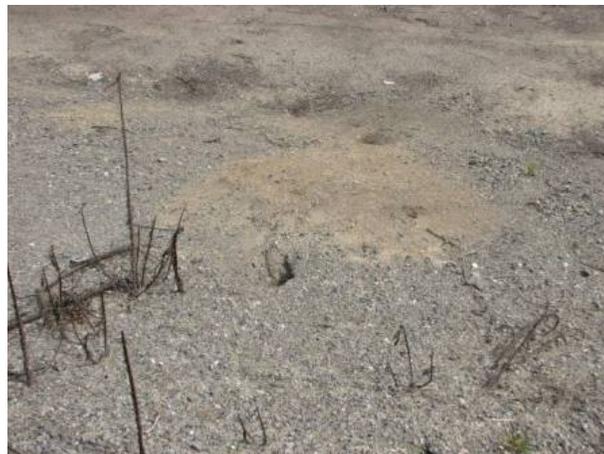
Levee Mile Report Line	3
Start Levee Mile	0.11
End Levee Mile	0.11
Location	Land Side
Category	Earthen Levee
Item	Animal Control
Rodent holes on the landside levee slope, photo taken spring 2012.	
johngw_f_20131021_573.jpg

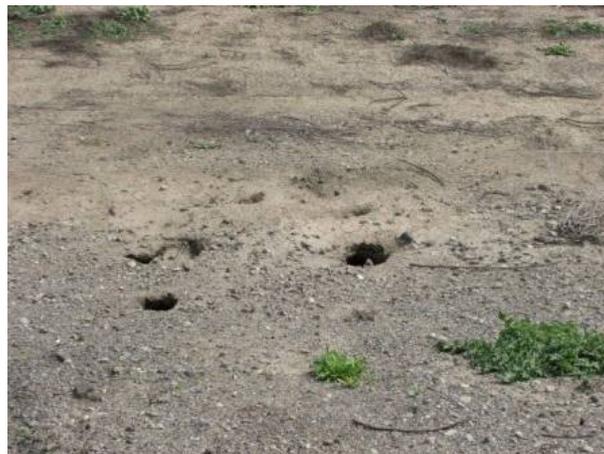
Levee Mile Report Line	5
Start Levee Mile	0.38
End Levee Mile	0.38
Location	Land Side
Category	Earthen Levee
Item	Animal Control
Rodent holes on the landside levee slope, photo taken spring 2012.	
johngw_f_20131021_574.jpg

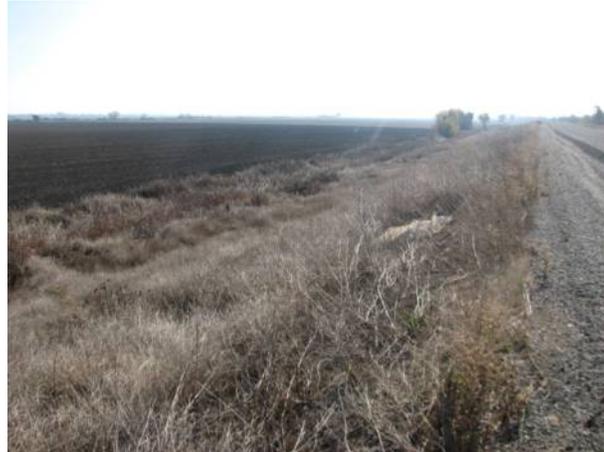
Levee Mile Report Line	6
Start Levee Mile	0.41
End Levee Mile	0.61
Location	Land Side
Category	Earthen Levee
Item	Vegetation
Tall vegetation blocks the visibility of the levee slope. Fall 2013	
johngw_f_20131126_354.JPG

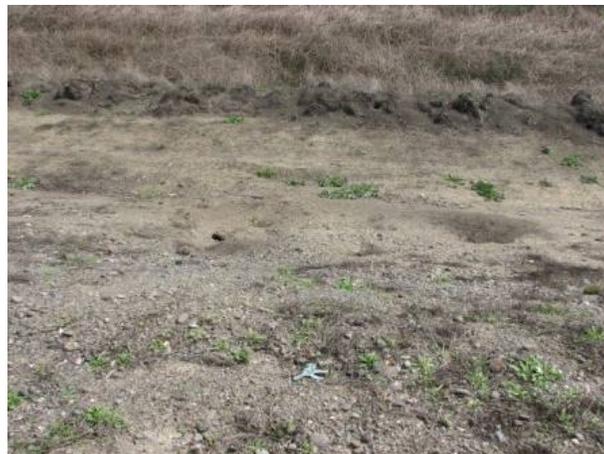
Levee Mile Report Line	7
Start Levee Mile	0.46
End Levee Mile	0.46
Location	Land Side
Category	Earthen Levee
Item	Animal Control
Rodent holes on the landside levee slope, photo taken spring 2012.	
johngw_f_20131021_575.jpg

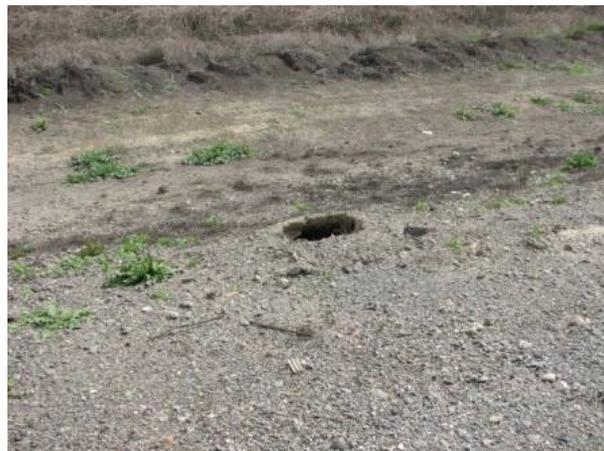
Levee Mile Report Line	7
Start Levee Mile	0.46
End Levee Mile	0.46
Location	Land Side
Category	Earthen Levee
Item	Animal Control
Many rodent holes with in 25' of each other, photo taken spring 2012.	
johngw_f_20131021_576.jpg

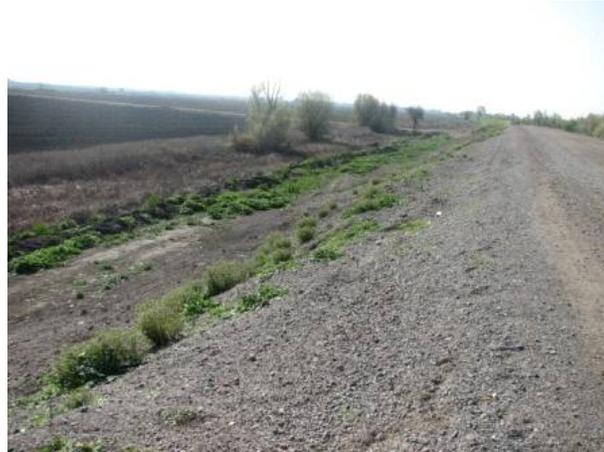
Levee Mile Report Line	8
Start Levee Mile	0.52
End Levee Mile	0.52
Location	Land Side
Category	Earthen Levee
Item	Slope Stability
Buldge at the landside toe of the levee, photos taken spring 2012.	
johngw_f_20131021_577.jpg

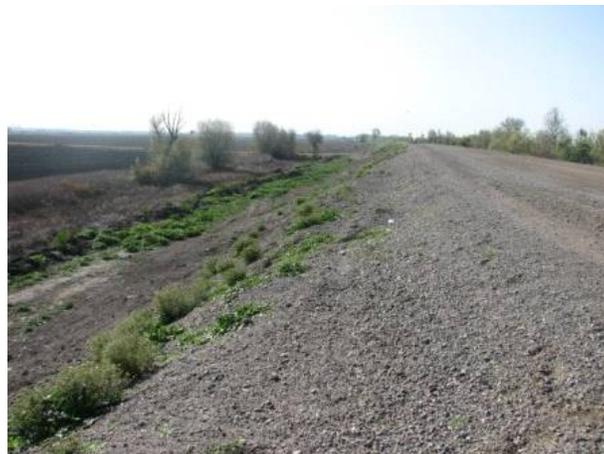
Levee Mile Report Line	8
Start Levee Mile	0.52
End Levee Mile	0.52
Location	Land Side
Category	Earthen Levee
Item	Slope Stability
Slope instability at shoulder of landside levee buldge at toe.	
johngw_f_20131021_578.jpg

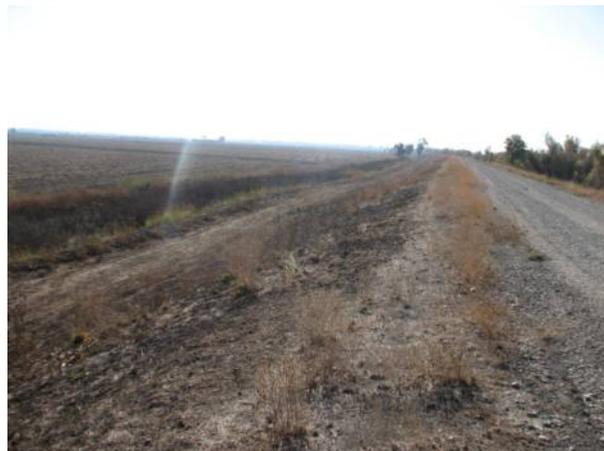
Levee Mile Report Line	9
Start Levee Mile	0.66
End Levee Mile	3.29
Location	Land Side
Category	Earthen Levee
Item	Vegetation
There is no unwanted vegetation blocking visibility of the levee slope. Fall 2013	
johngw_f_20131104_283.JPG

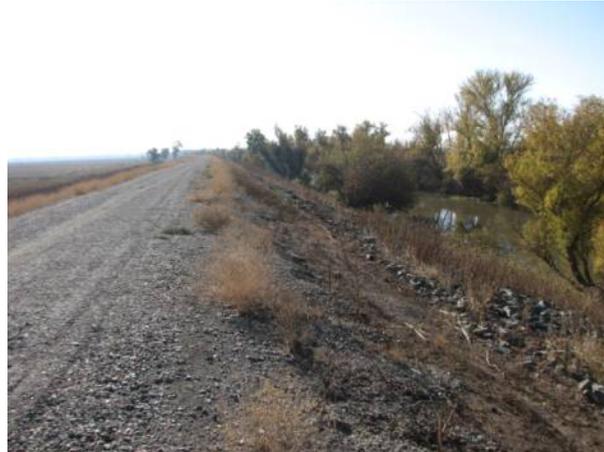
Levee Mile Report Line	10
Start Levee Mile	0.66
End Levee Mile	3.29
Location	Water Side
Category	Earthen Levee
Item	Vegetation
No unwanted vegetation blocking visibility on the levee slope. Fall 2013	
johngw_f_20131104_284.JPG

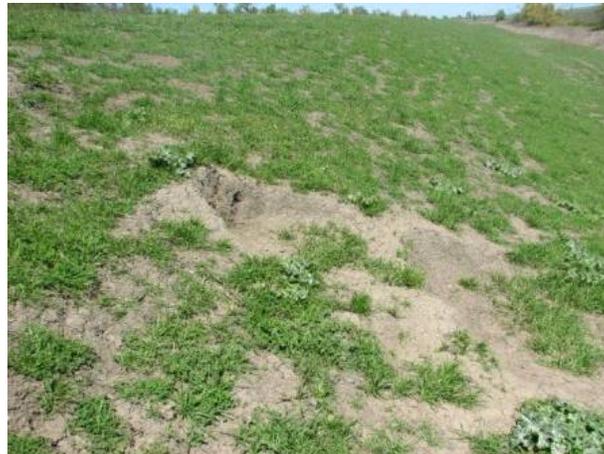
Levee Mile Report Line	12
Start Levee Mile	2.20
End Levee Mile	2.20
Location	Land Side
Category	Earthen Levee
Item	Slope Stability
There is slope instability with three step like spots. The cuts are 1' to 1.5' deep. Photo taken spring 2012.	
johngw_f_20131021_579.jpg

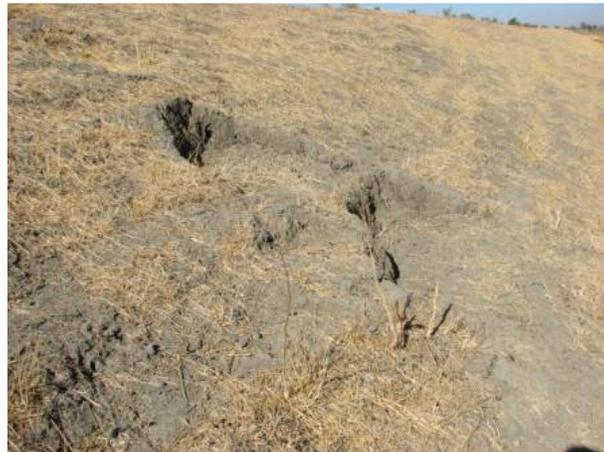
Levee Mile Report Line	12
Start Levee Mile	2.20
End Levee Mile	2.20
Location	Land Side
Category	Earthen Levee
Item	Slope Stability
Slope instability. Photo fall 2012.	
johngw_f_20131021_580.jpg

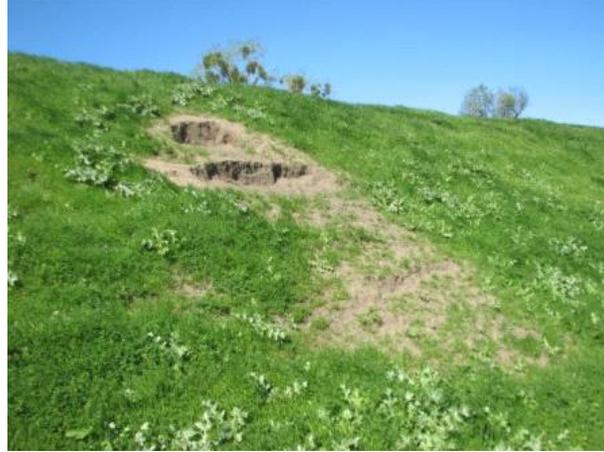
Levee Mile Report Line	12
Start Levee Mile	2.20
End Levee Mile	2.20
Location	Land Side
Category	Earthen Levee
Item	Slope Stability
Slope instability is still there. Spring 2013	
johngw_f_20131021_581.JPG
